**SHORE UP**

**COMMUNITY  
RESILIENCE  
ADAPTATION  
PROJECT FOR  
THE NORTH  
SHORE OF  
STATEN ISLAND**

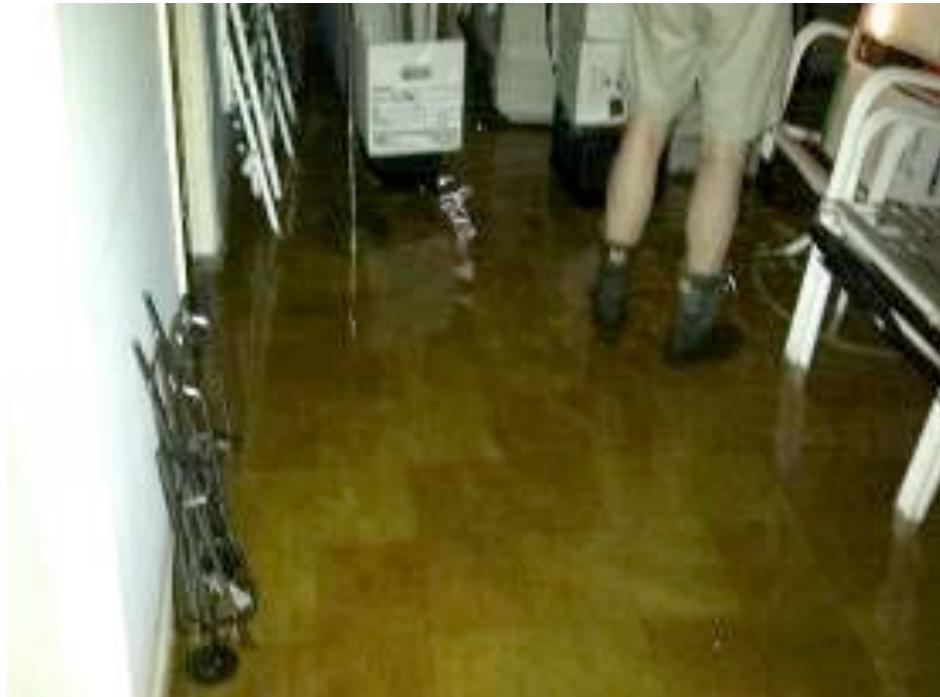
## **Basement Flooding**

The North Shore of Staten Island was developed quickly with little consideration for drainage. Therefore, many North Shore residential communities are still using a drainage system that is more than 65 years old.

The heavy downpour produced by Hurricane Irene in late August, 2011 rapidly saturated the ground and water began bubbling up from under the basement floors into many homes like a spring. Even homes that had never

experienced water seepage soon found they had to bail or pump themselves out.

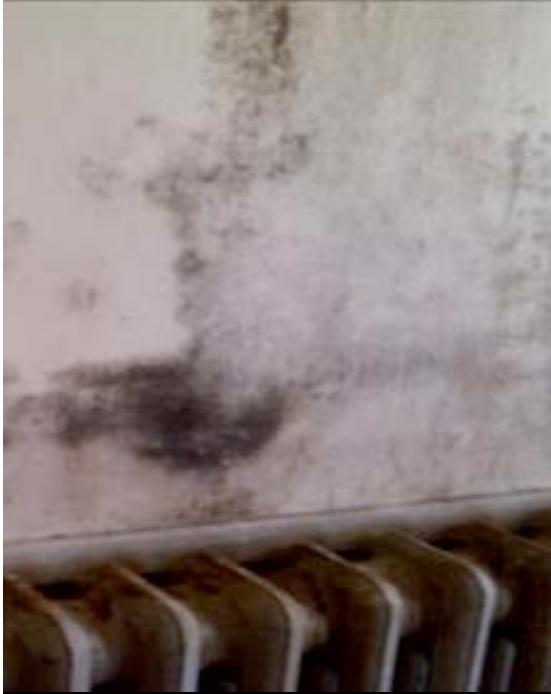
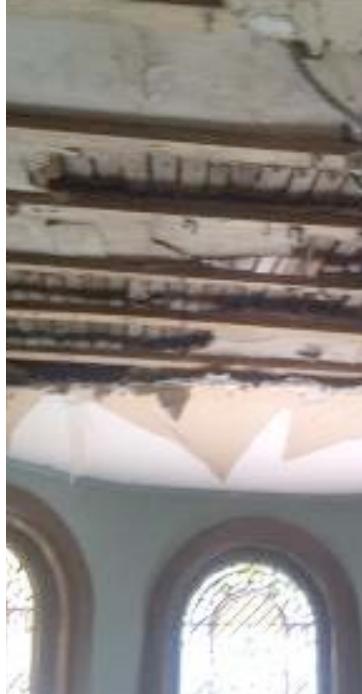
### **The Reformed Church on Staten Island**

Hurricane Irene caused significant mold damage on walls of The Reformed Church on Staten Island.

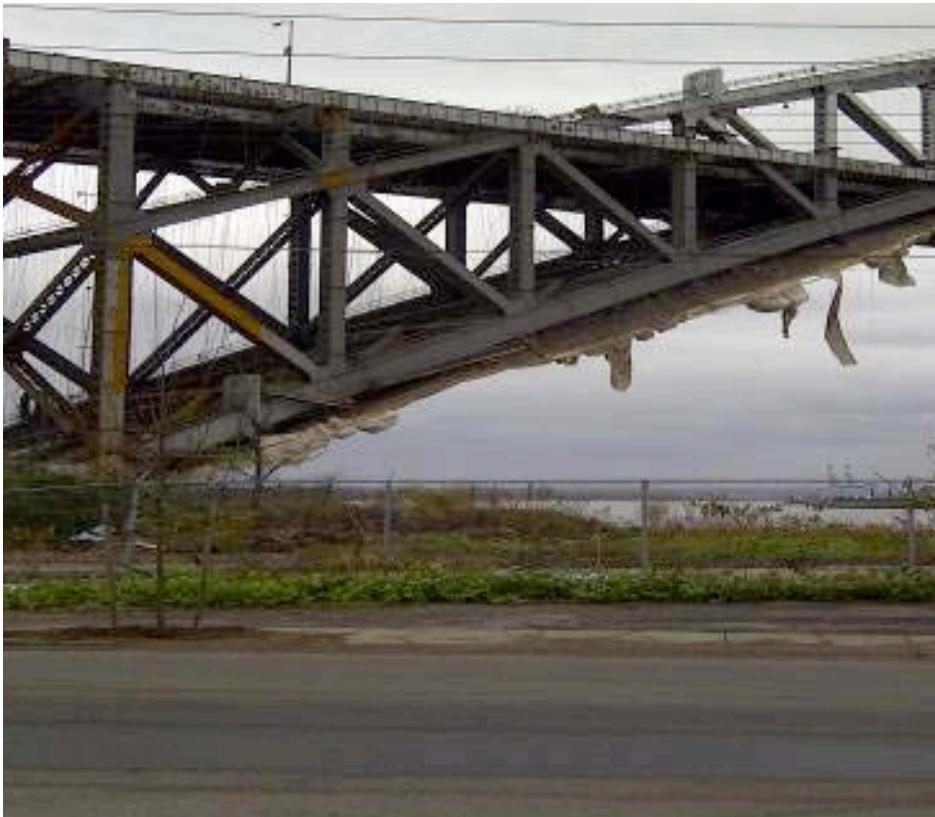
**The Bayonne Bridge One Day After Hurricane Sandy  
10.30.2012**

residents living across the street from the old Archer Daniels Midland (ADM) site reported seeing the storm surge from the Kill Van Kull wash over the ADM site and the water covered the tops of the trees on the property.

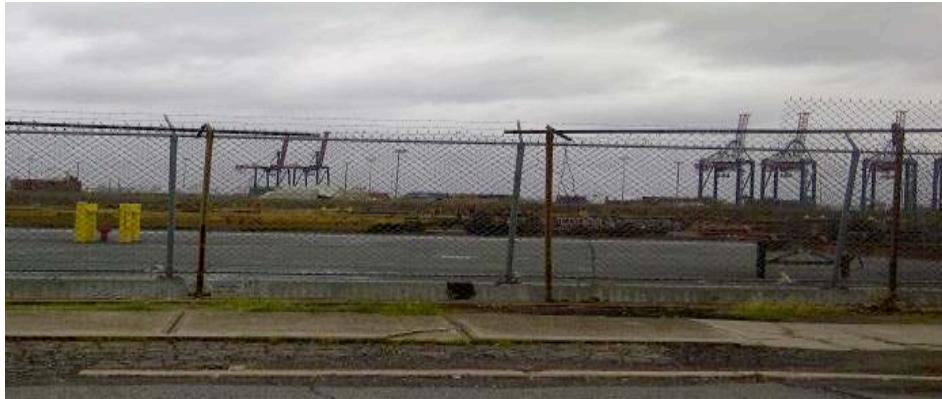
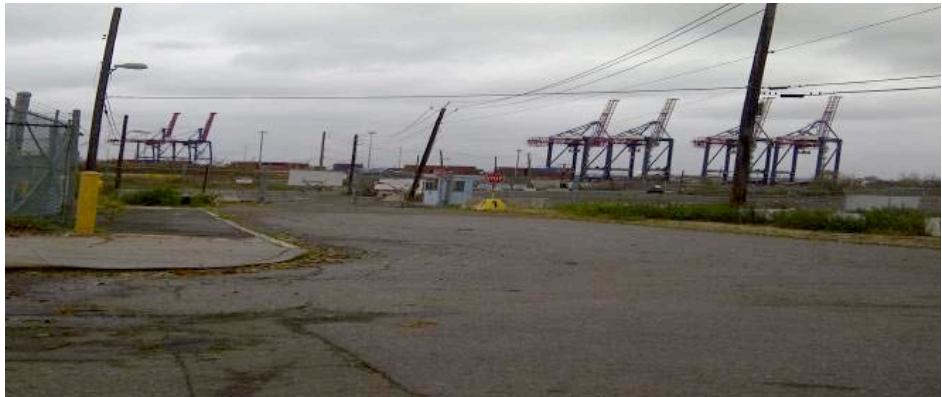
### **Howland Hook**

According to the Port Authority of New York and New Jersey, the Howland Hook/New York Container Terminal experienced 14-foot storm surges during Hurricane Sandy. Shipping containers were thrown around by the winds as if they were toys.

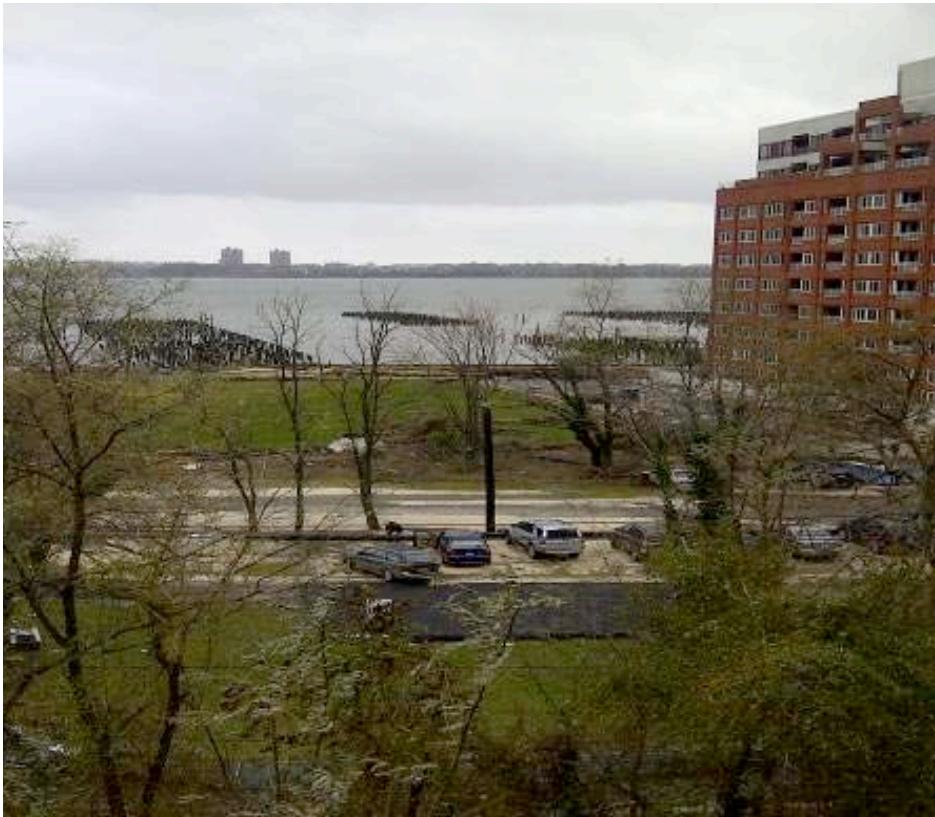
### **Bay Street Landings**

Residents living at Bay Street Landings experienced 12-foot storm surges that flooded the first floors of their buildings and pushed cars in the parking lot to the edges of the property.

One resident said that when the storm surge came in, it only took minutes for debris from the pier and bulkhead to be pushed onto

the promenade and street. Bay Street Landings has one street leading to and from the site, all other egress from this below-grade property would have to be traversed by foot.

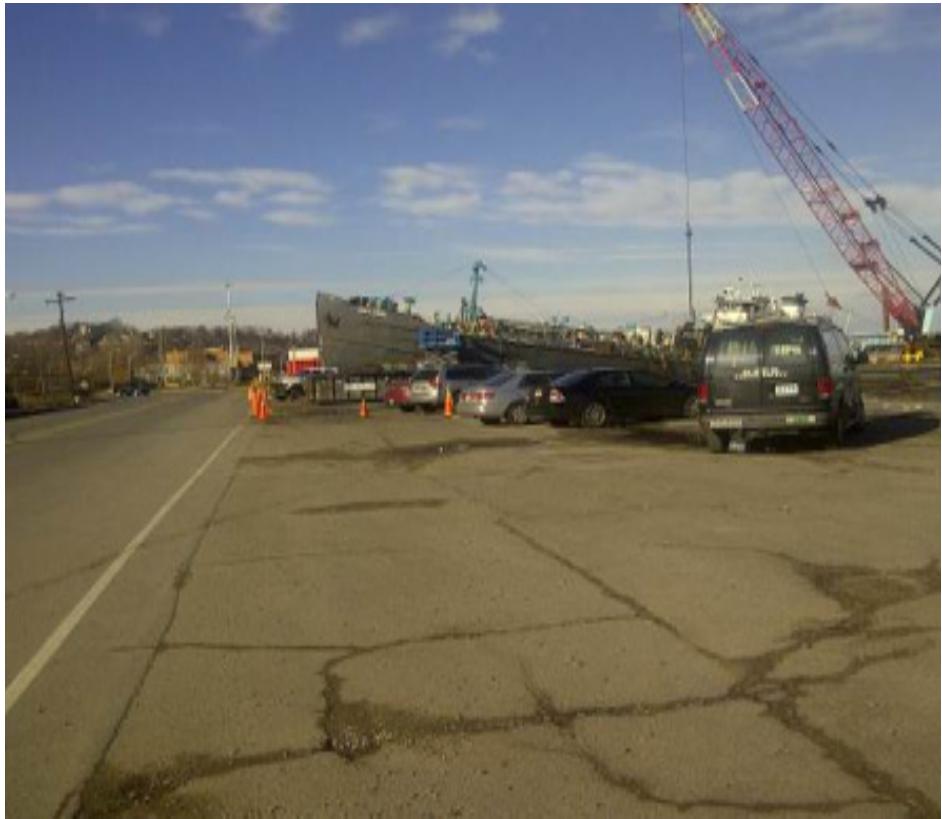
**Front Street, Stapleton Shoreline Erosion  
12.05.2012**

The unmanned John B. Caddell, a tanker, became unmoored and drifted in the Narrows before eventually becoming beached in the parking lot at Front Street, Stapleton, where it remained until it was towed away.

According to people that work along this stretch of Front Street, the area has long suffered from flooding associated with Nor'Easters. In addition, the shoreline has been eroding for some time.

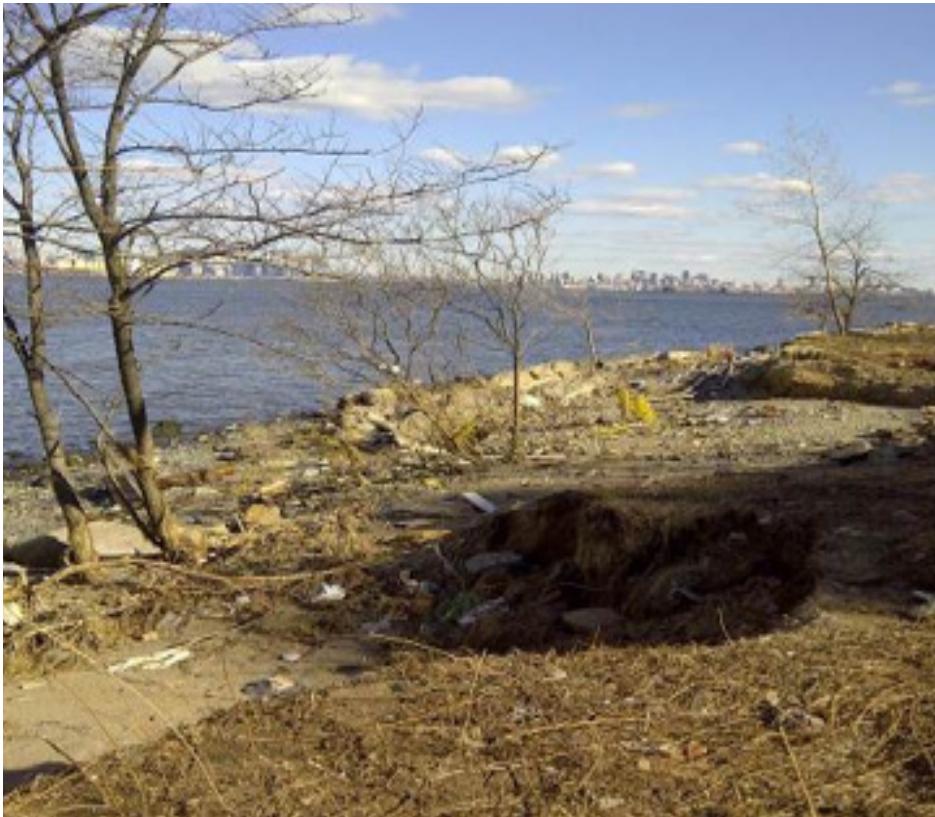
**St. George, Shoreline Erosion  
01.18.2013**

St. George's waterfront on Bank Street also yielded interesting results: under the blacktop was white sand. But the shoreline where residents would park their vans overnight to do night fishing were quickly eroded away during Sandy.

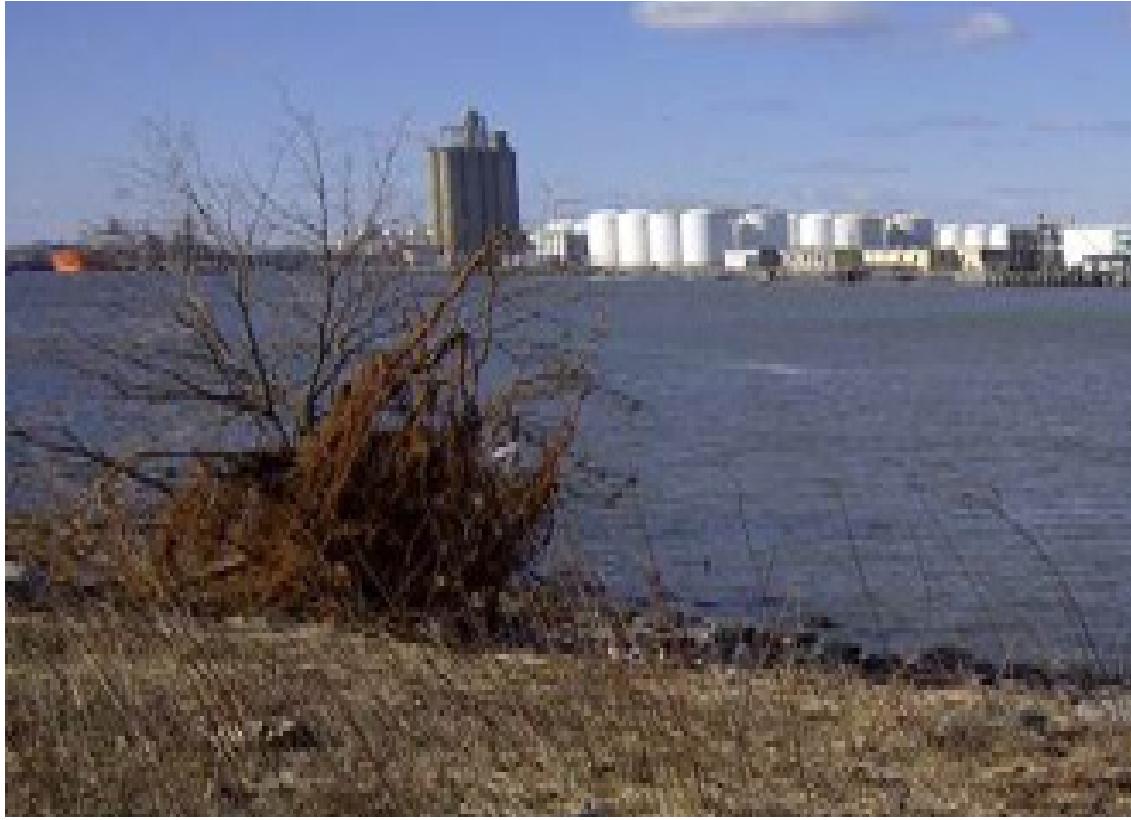
**St. George's Waterfront at Bank Street across from Bayonne, New Jersey's Industrial waterfront**

Along this area of the waterfront, as the Kill Van Kull river bends, the image above shows several oil and gas tanks and a power plant in Bayonne, New Jersey. Bayonne is directly across the river from Staten Island's North

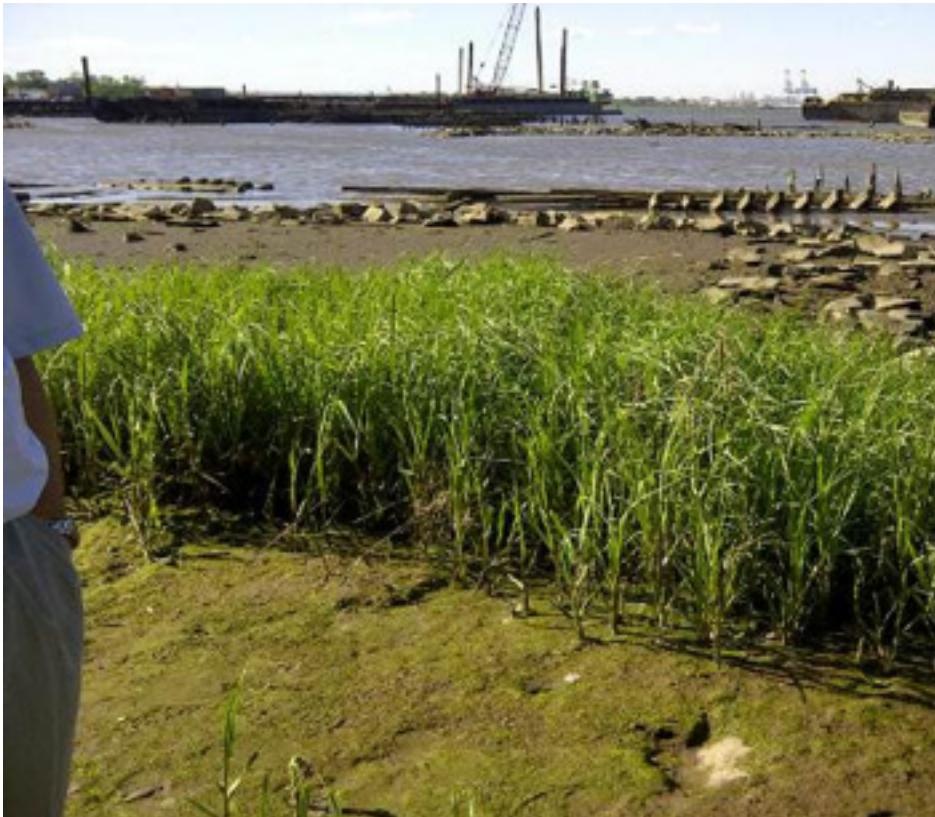
**Mariners Harbor, Van Name and Van Pelt Tidal Wetlands**  
**06.13.2011**

Above, Van Name and Van Pelt mud flat with Spartina grass. Three acres of tidal wetlands and eleven acres of underwater property.

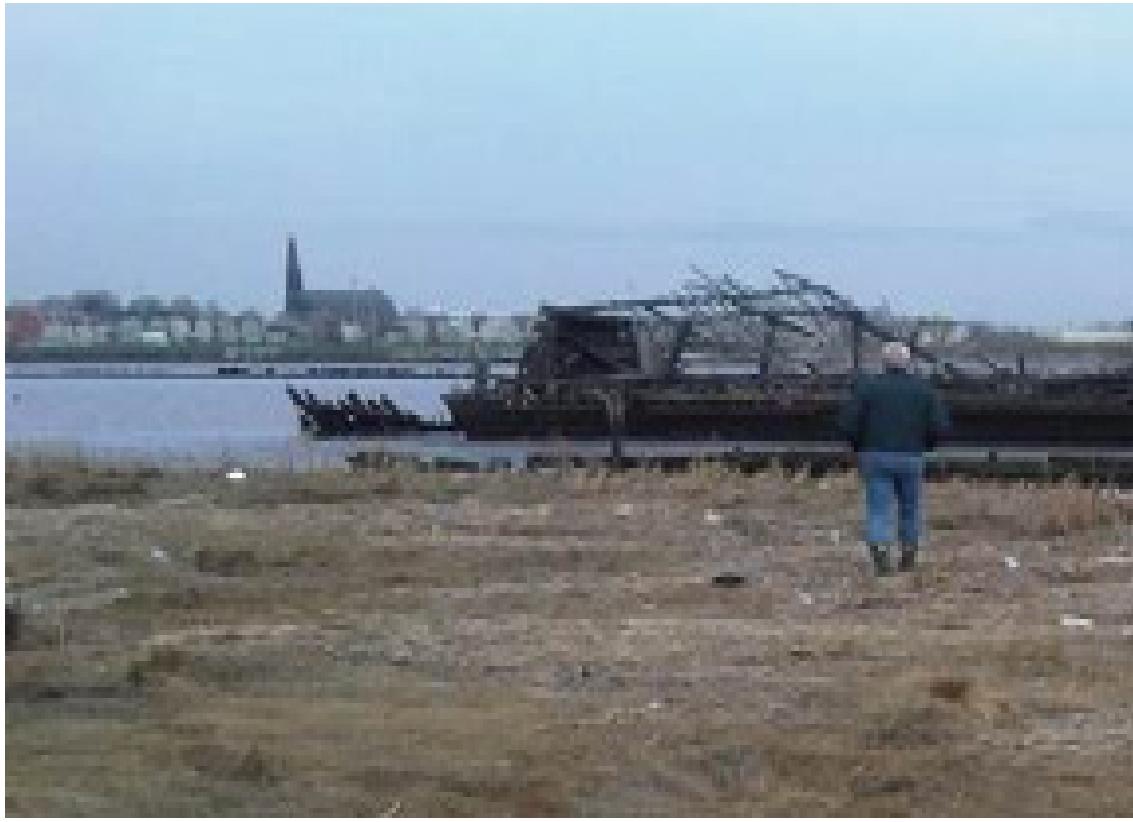
**Arlington, Arlington Marsh Tidal Wetlands and Cove**  
**04.15.2011**

There is, of course, Arlington Marsh and Cove, 80 acres of tidal wetlands located at the northwestern corner of Staten Island, connecting the communities of Mariners Harbor and Arlington.

The residential communities that were flanked by, or surrounded by, Arlington Marsh's tidal wetlands and 107.5 acres of Mariners Marsh freshwater wetlands, as well as the wetlands at Old Bridge Creek, were not flooded during Hurricane Sandy.

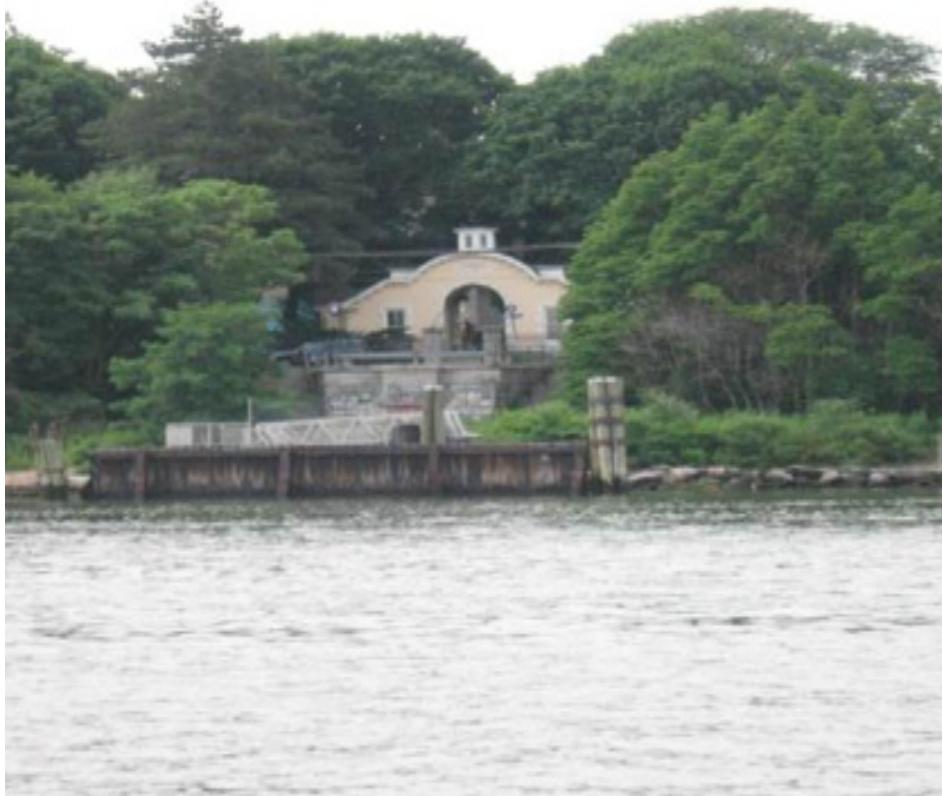
**Snug Harbor Cultural Center Waterfront: Shoreline Erosion  
06.27.2014**

According to staff, during Hurricane Sandy, the floating dock at Snug Harbor's waterfront was taken during the storm surge and pulled out into the Kill Van Kull where it floated about one and a half miles before sinking in the river. A good portion of the waterfront at this location also experienced shoreline erosion.

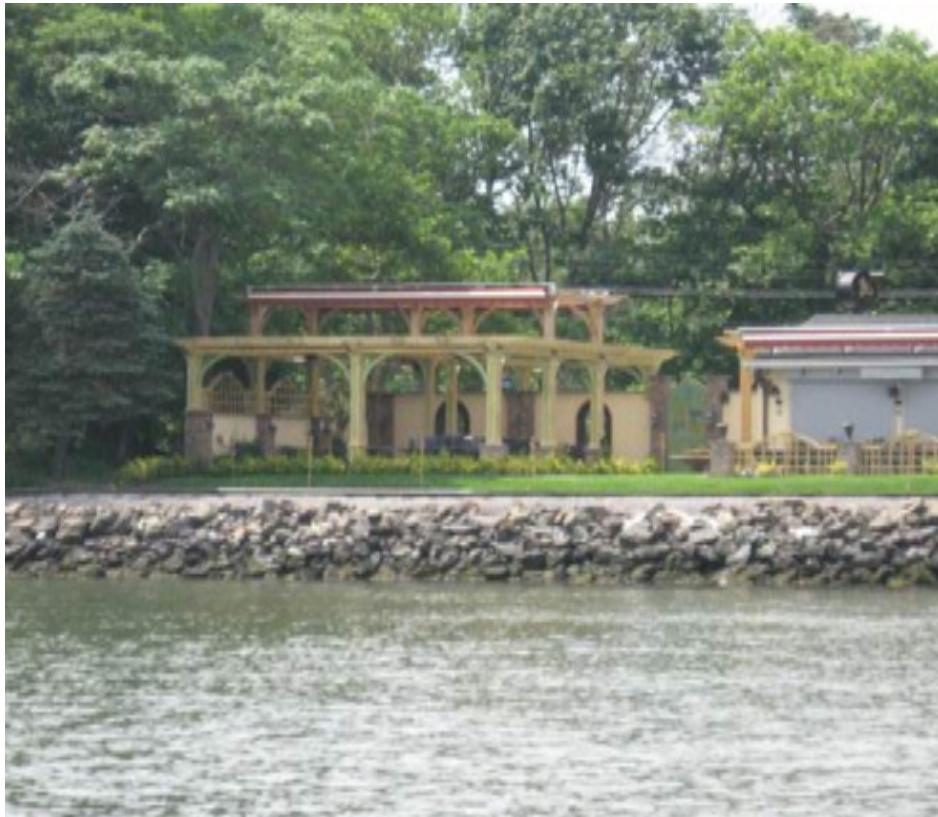
**Livingston, Shoreline Riprap: Blue Restaurant Waterfront**  
**06.27.2014**

Blue Restaurant has riprap along their waterfront but even this may not be sufficient enough to protect their business and or the residential community across from them on Richmond Terrace. In addition it does not run concurrent with any other properties on either side of it. During Sandy, all properties along the North Shore waterfront flooded.

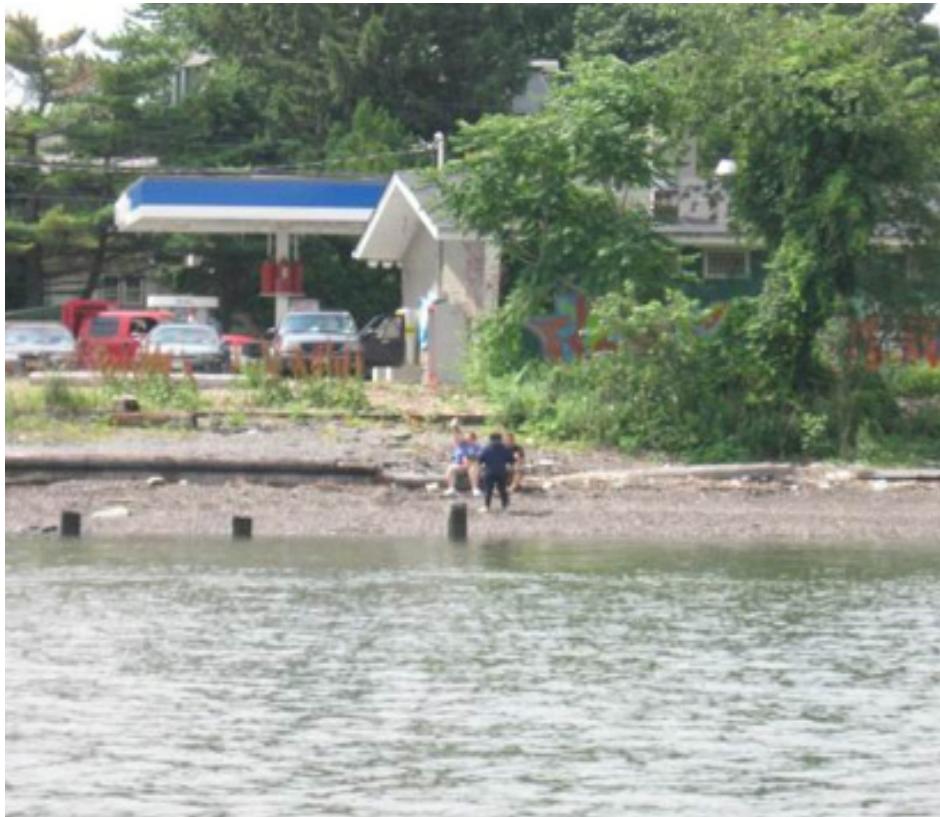
**Livingston/West Brighton, Shoreline Erosion: Gas Station  
06.27.2014**

There is no shoreline protection at all on this property's waterfront and during Sandy it was underwater.

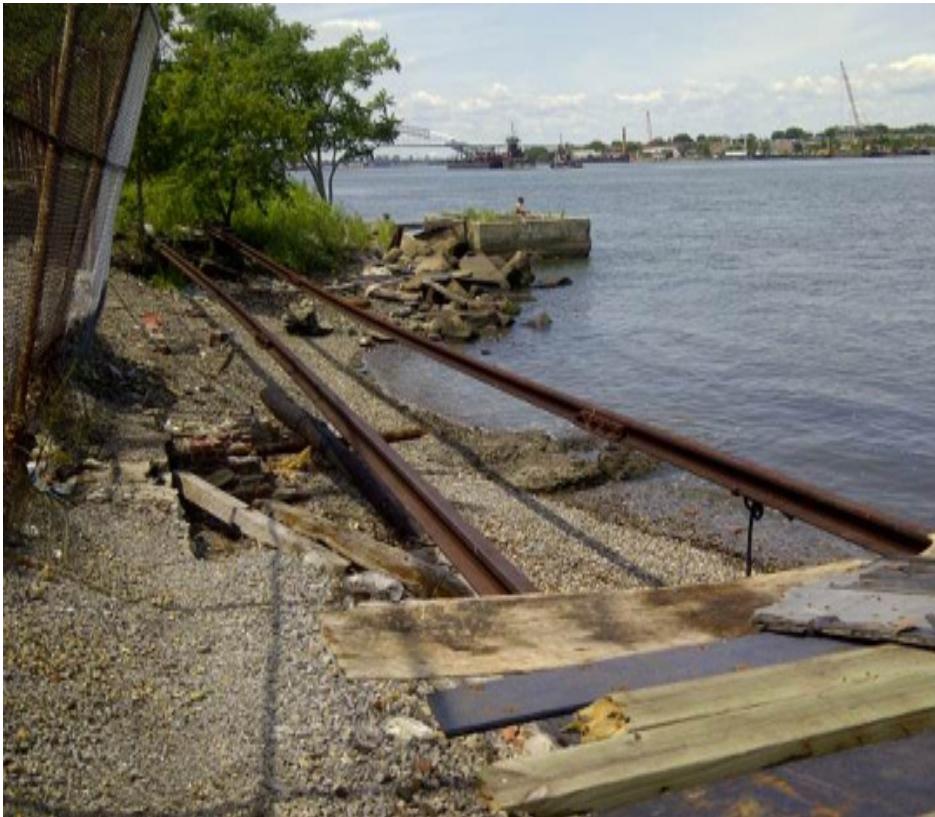
**West Brighton, Shoreline Erosion: North Shore Rail Line**  
**07.18.2014**

The North Shore Rail line's easement butts up against Con Edison's property and in this photo it can be seen that the easement's erosion issues are now impacting Con Edison's property, causing the fence to tilt and the black top of the parking area to crack and develop sinkholes.

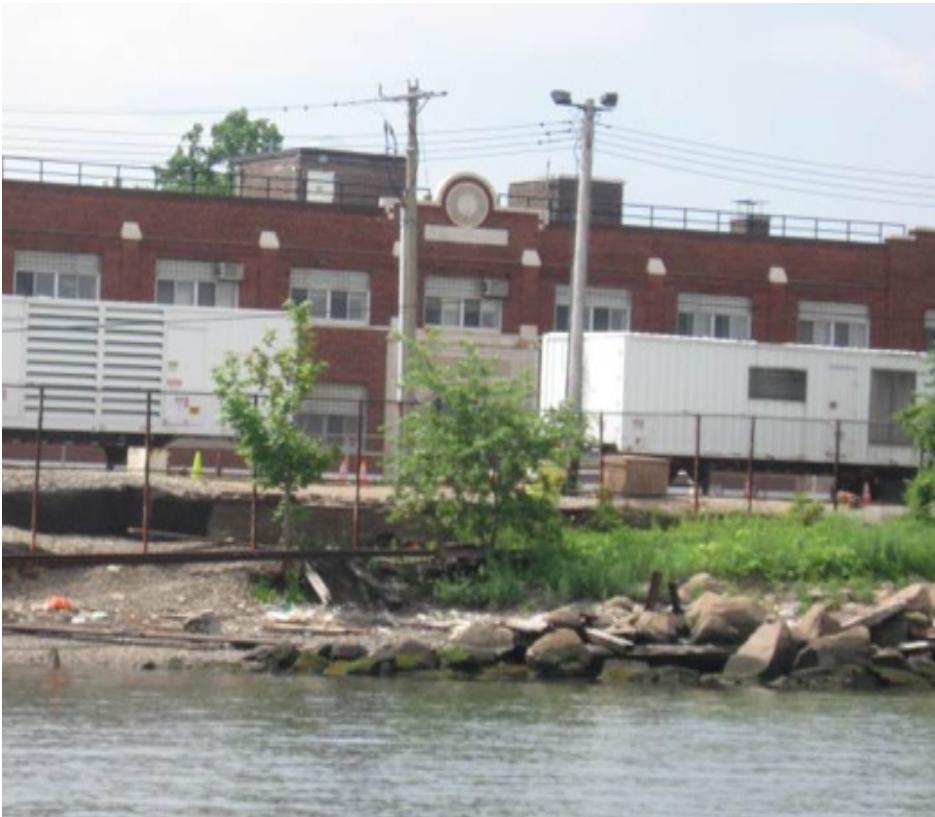
**Kill Van Kull**

In terms of any kind of berm protection, there is a small amount of riprap that is on the western portion of the shore line. However, it is obviously not running the length of the property and therefore does not offer any protection from sea level rising, storm surges or flooding.

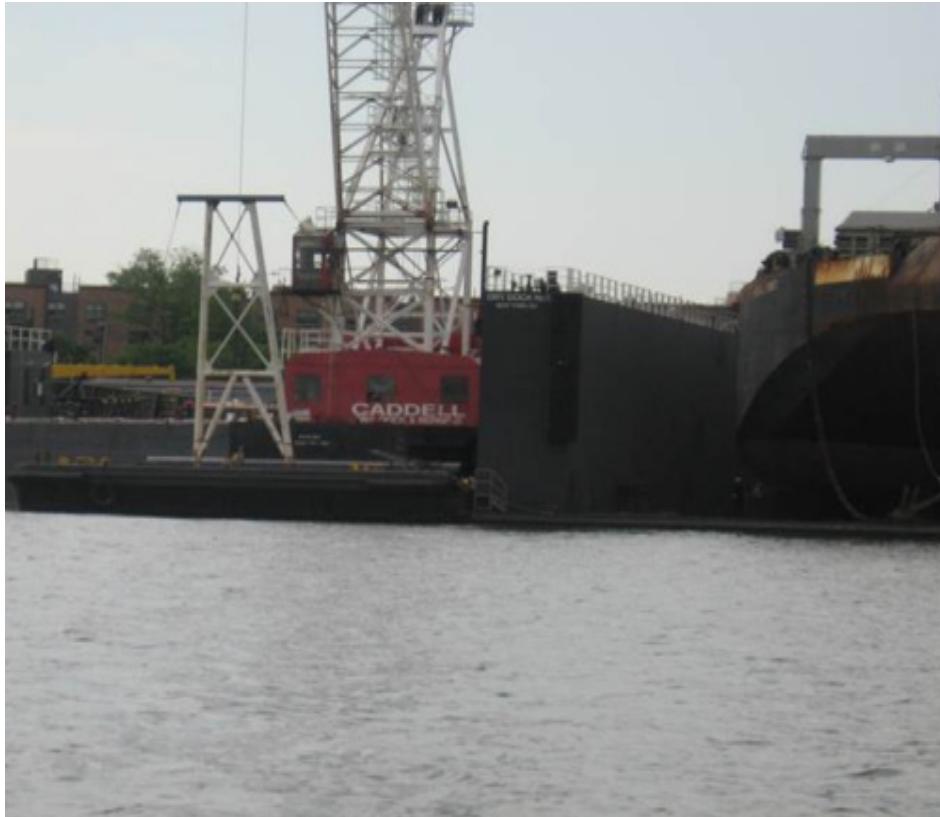
### **West Brighton, Bulkhead: Caddell Dry Dock 06.27.2014**

Caddell Dry Docks has bulkheads for its property. However, these bulkheads would not be tall enough to protect the properties or residents behind this business on Richmond Terrace. During Hurricane Sandy the first floor of the Markham Garden Homes flooded.

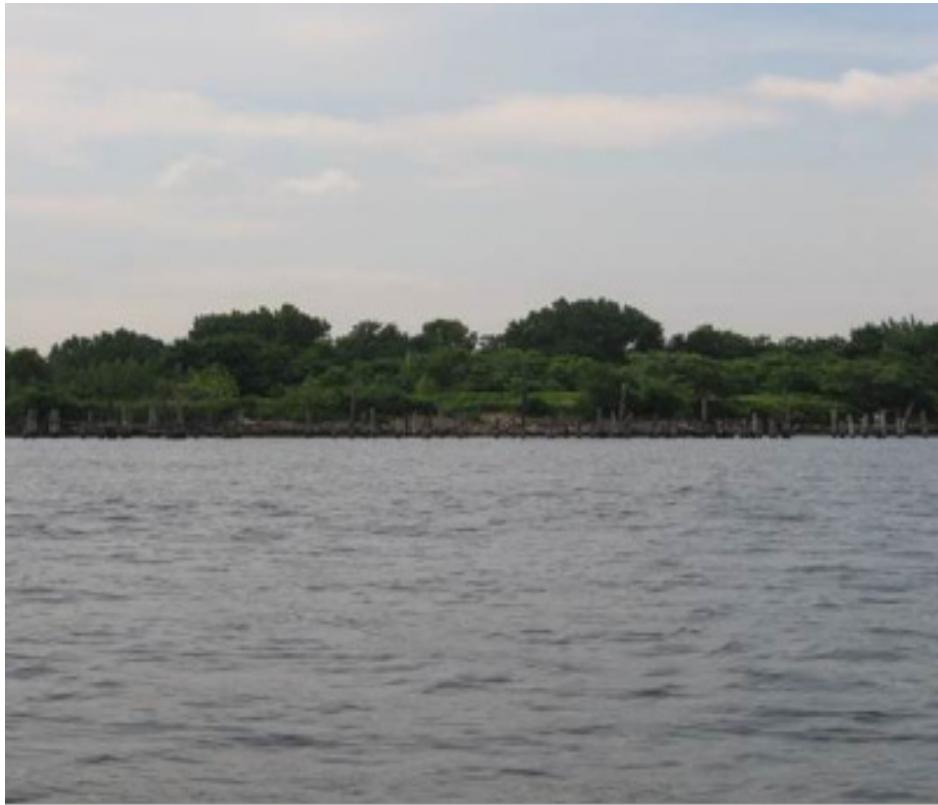
**West Brighton, Shoreline: Heritage Park**

The shoreline of Heritage Park has old piers and bulkheads but no real shoreline protection from the Kill Van Kull. The waterside of Heritage Park (formerly Blissenbach Boat Marina) wetlands mitigation funded by Caddell Dry Dock.

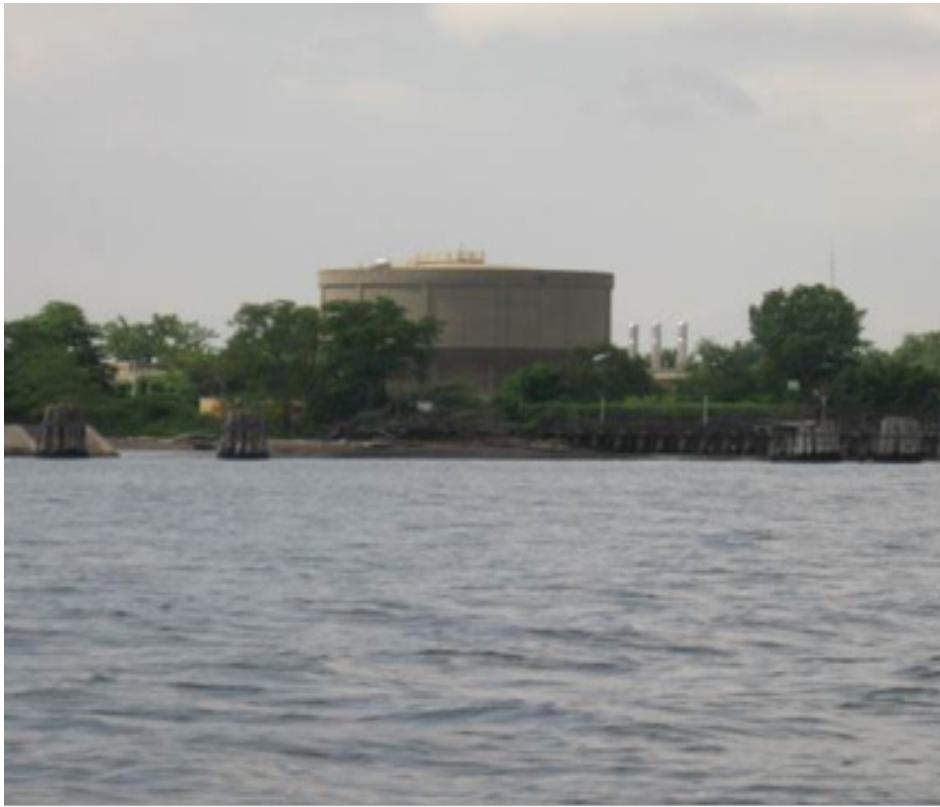
**West Brighton/Port Richmond, Bulkhead & Pier**  
**06.27.2014**

During Sandy, this section of Richmond Terrace, as well as the sewer treatment plant, flooded due to the storm surge. Slightly west of the sewer treatment plant is Bodine Creek's outflow to the Kill Van Kull.

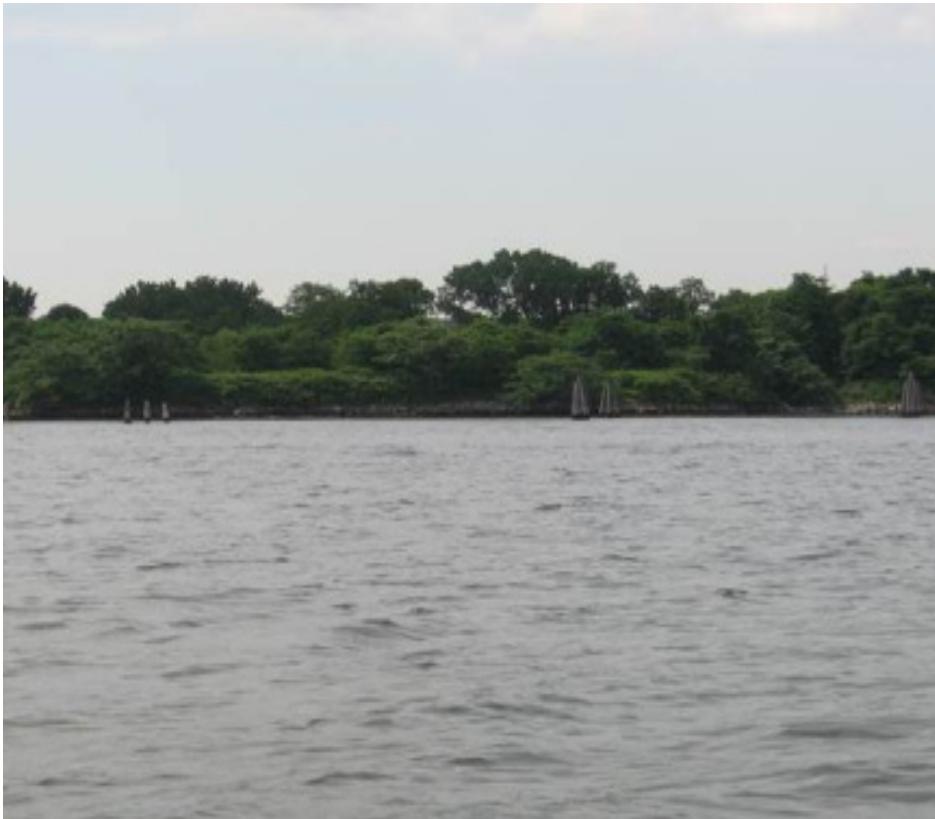
**Port Richmond, No Resiliency Buffer**

After the DEP Port Richmond Sewer Treatment Plant, there is a small stretch of natural shoreline with what looks to be old pilings but once again no protective buffer. On the Richmond Terrace side, there is a combination of commercial and residential properties.

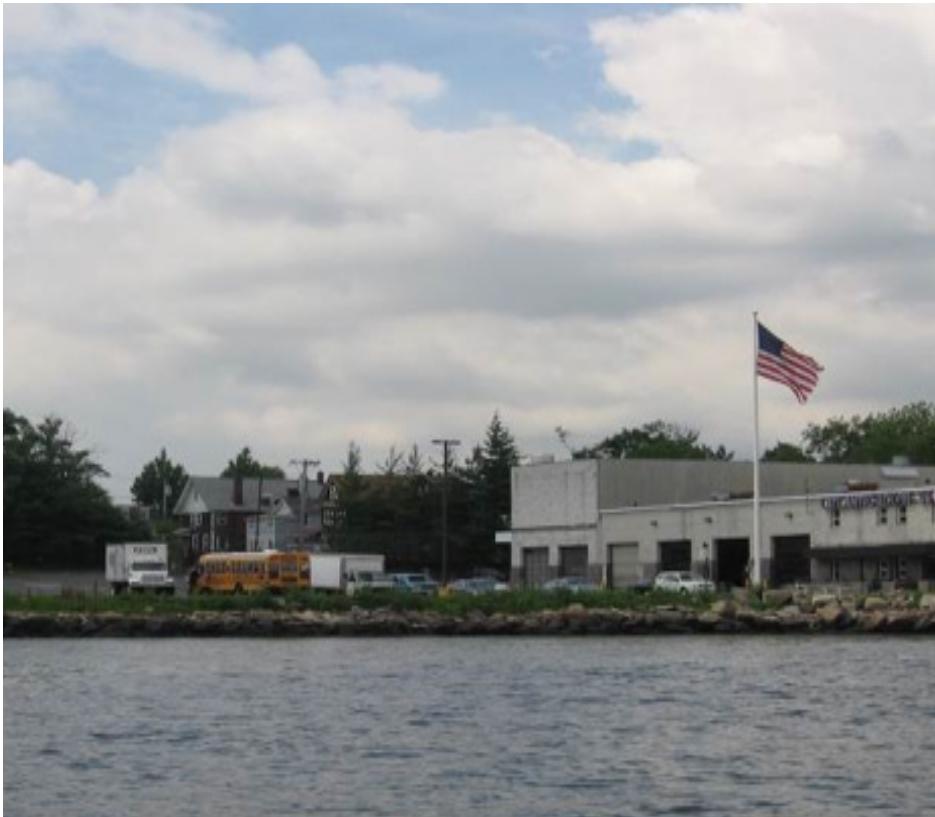
**Port Richmond, Riprap: Atlantic Express Bus Depot  
06.27.2014**

During Hurricane Sandy this bus depot and all of North Street was submerged in the storm surge. The day after Sandy, residents began putting damaged items from their homes on the curb. In 2013, Atlantic Express filed for bankruptcy and went out of business at this location.

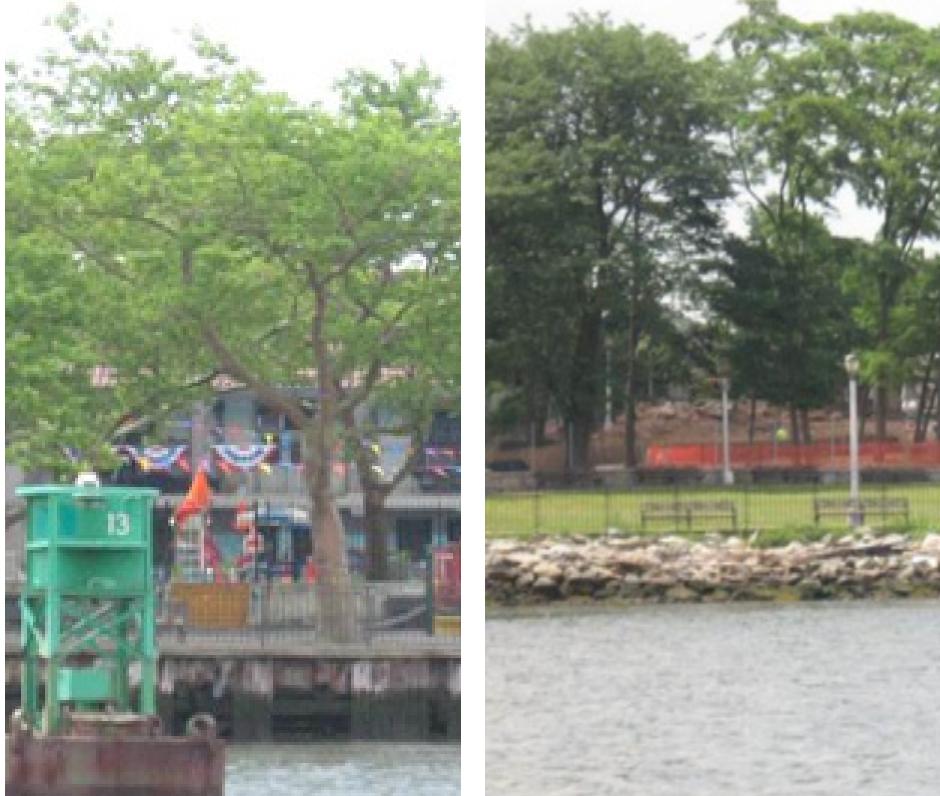
**Faber Park and Pool, Port Richmond**  
**06.27.2014**

Faber Park and Pool has a combination use of Riprap on its property. The lower part of Faber Park (above, right) was inundated during Hurricane Sandy.

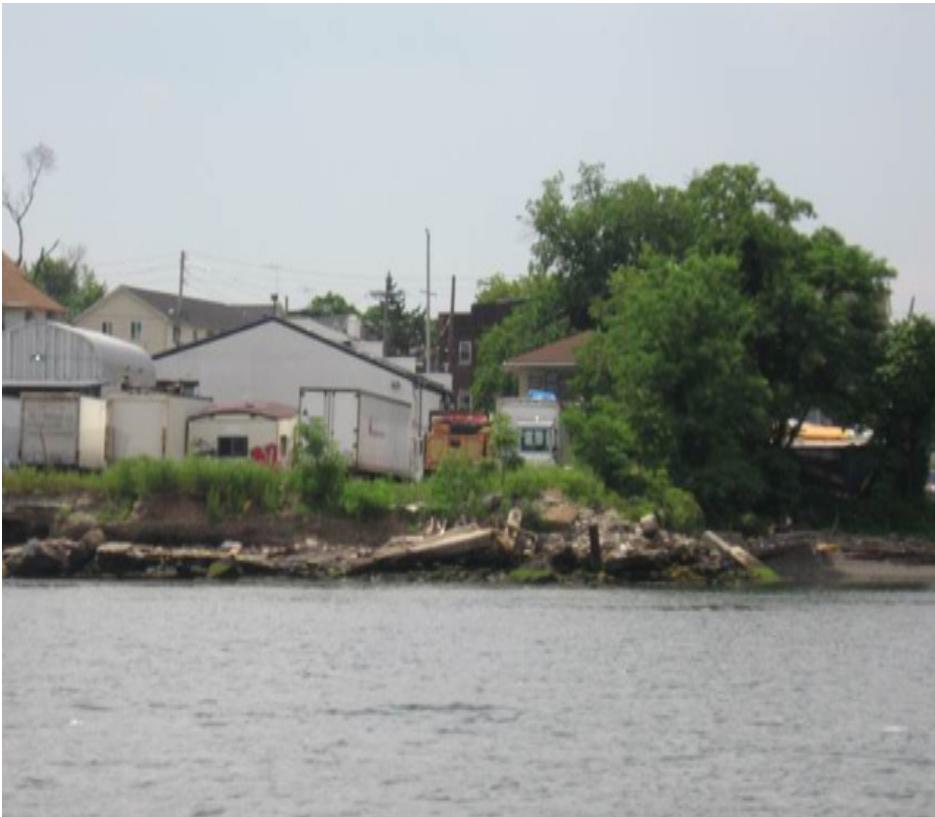
### **Truscanti Boat Company Property**

Crossing the street end of Nicholas Avenue on the waterfront the next property is old the Truscanti Boat Company property. There is obviously no storm surge or flood protection for this section of the waterfront.

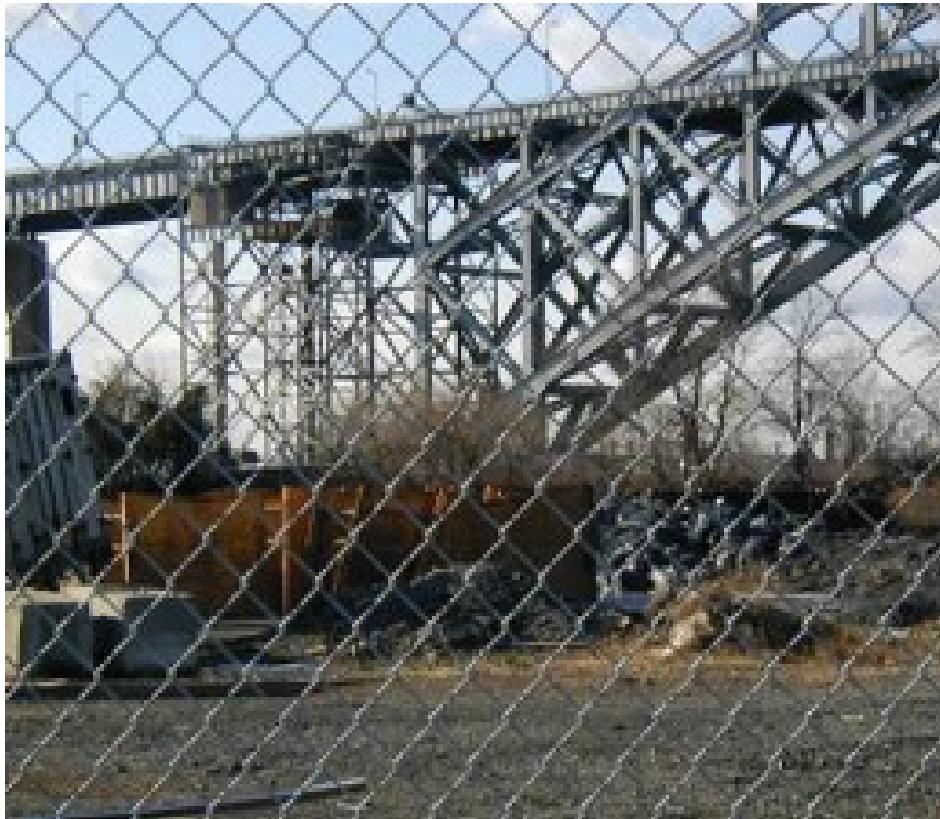
**Port Richmond and Elm Park, Shoreline Erosion  
06.27.2014**

Above is a NSWC archival photo of the old Archer Daniel Midlands Company and Truscanti Boat Company site under the Bayonne Bridge.

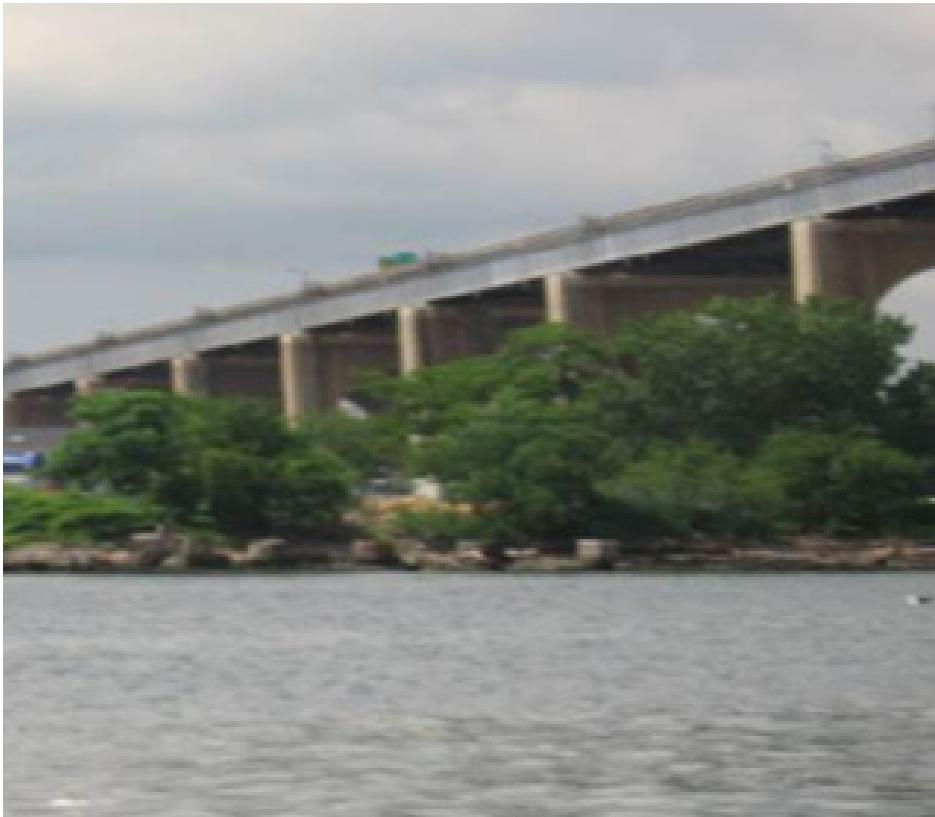
**Archer Daniels Midland Company**  
**06.27.2014**

During Sandy, the old Truscanti Boat Company property was completely submerged with the storm surge, as was Richmond Terrace.

East of the Bayonne Bridge, this clump of small trees to the right in the photograph is all that is left of the (1939 to 1942) Archer Daniels Midland Company piers. You can see a little bit of the stone portion of the piers if you look closely at the shoreline in the photo above. The shoreline has been eroding for a number of years.

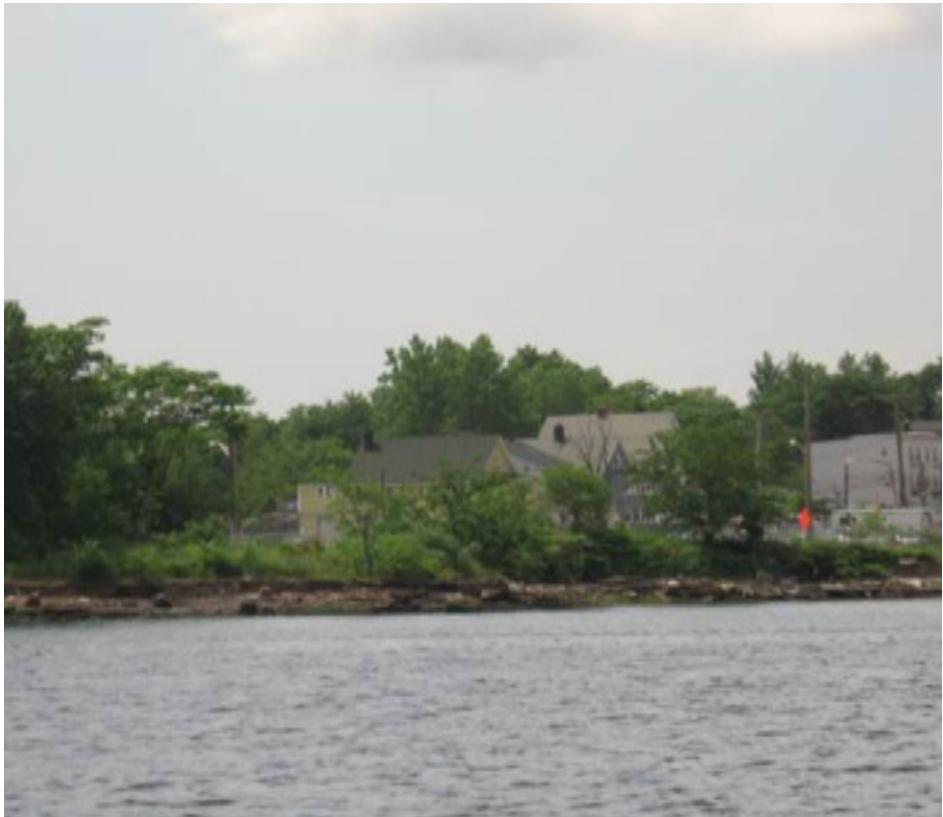
**Mariners Harbor, Shoreline Erosion  
06.27.2014**

West of the Bayonne Bridge along Richmond Terrace, the waterfront shows signs of erosion and debris with what may have also been a small riprap and or bulkhead at one time.

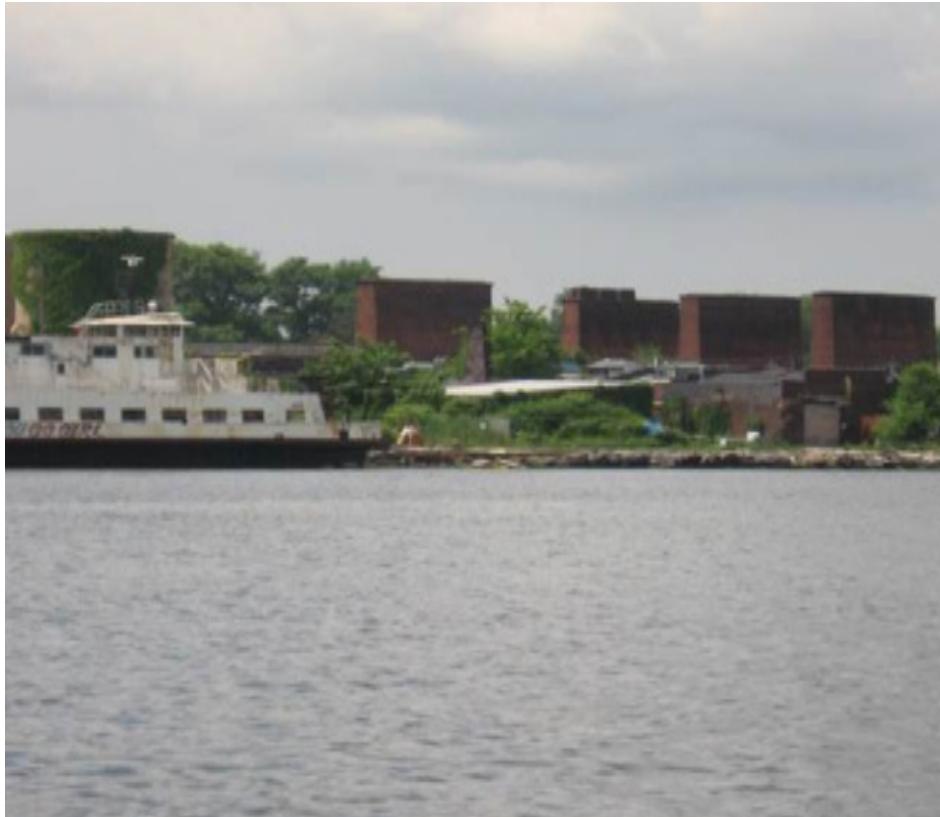
**Mariners Harbor, Shoreline Erosion  
06.27.2014**

This stretch of waterfront along the Kill Van Kull in Mariners Harbor shows some rocks but mostly floating wood debris. There is nothing here that would offer resiliency protection for the commercial and residential properties that are on Richmond Terrace. The red brick structures are foundry ovens.

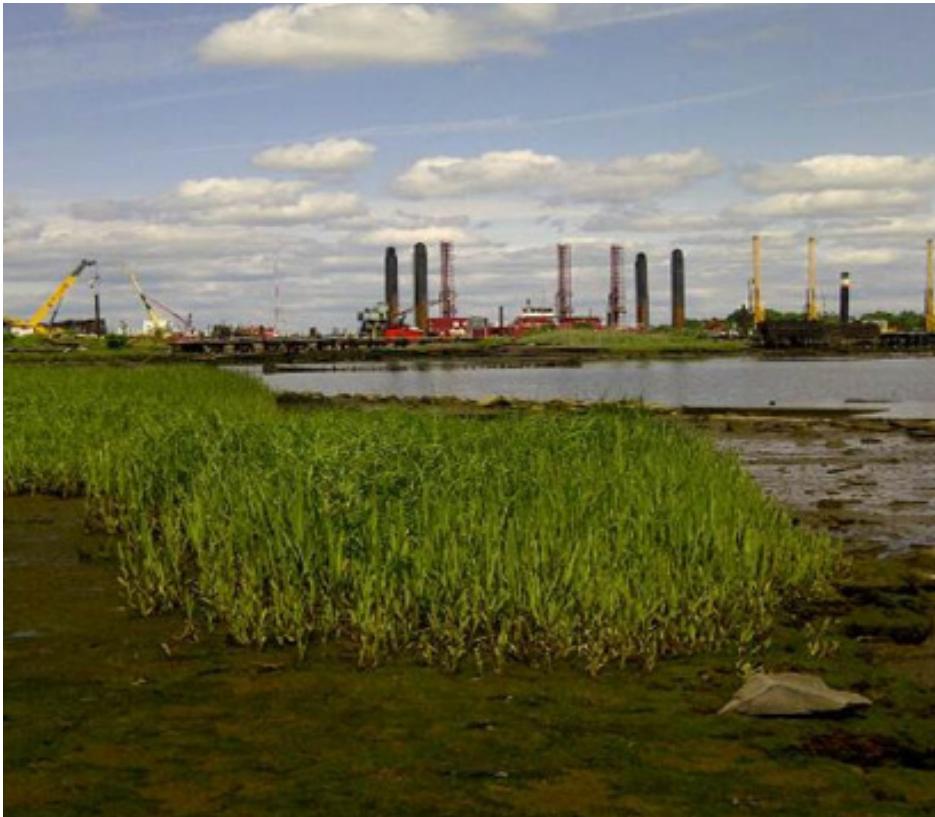
**Mariners Harbor, Natural Shoreline Protection**  
**06.27.2014**

From the land side of Richmond Terrace, Van Name, Van Pelt Park's wetlands, mud flat, Spartina grass, and cove. Great Lakes Dredging Company in the background.
