**SHORE UP**

**COMMUNITY  
RESILIENCE  
ADAPTATION  
PROJECT FOR  
THE NORTH  
SHORE OF  
STATEN ISLAND**

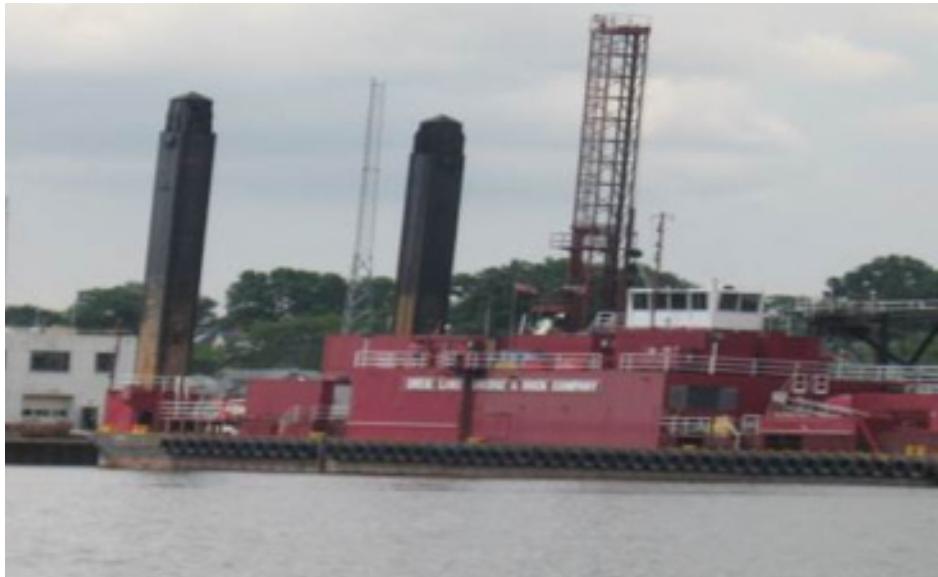
**Mariners Harbor, Bulkhead and Piers**  
**06.27.2014**

Great Lakes Dredging has a bulkhead.

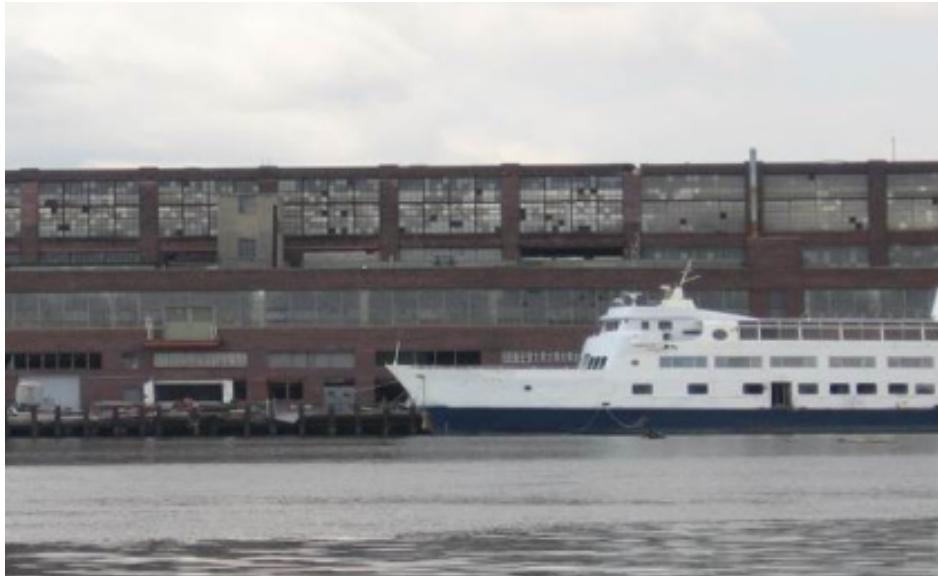
**Mariners Harbor, Bulkhead and Piers of Old Bethlehem Steel Shipbuilding Company**

Inundated during Hurricane Sandy: Richmond Terrace after Van Pelt to South Avenue, lower De Hart Avenue, lower Union Avenue, lower Coonley Court,

lower Bush Avenue, lower Harbor Road, lower Lockman Avenue, lower Andros Avenue, lower Mersereau Avenue, and lower Post Lane.

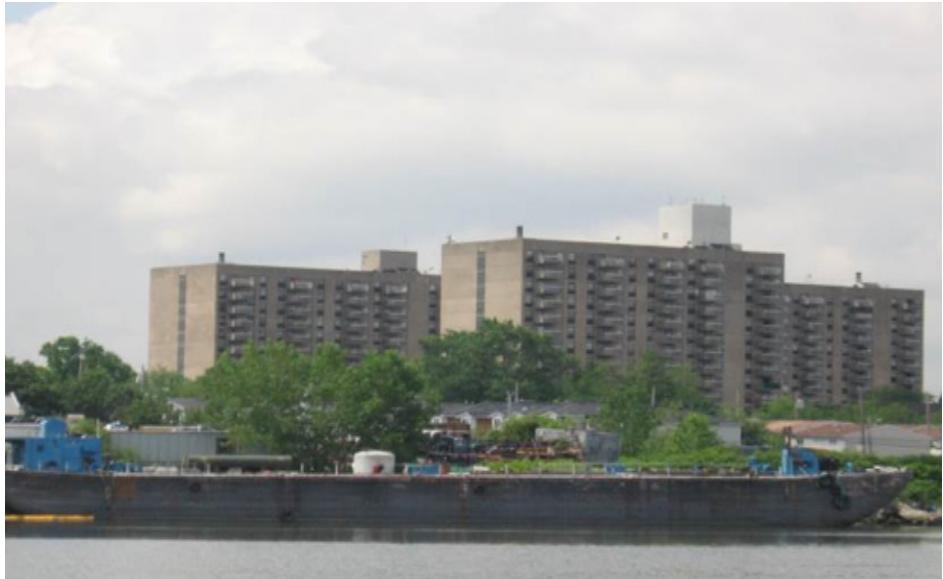
**Mariners Harbor, Bulkhead**  
**06.27.2014**

Arlington Terrace Apartments  
and residential homes in the  
background.

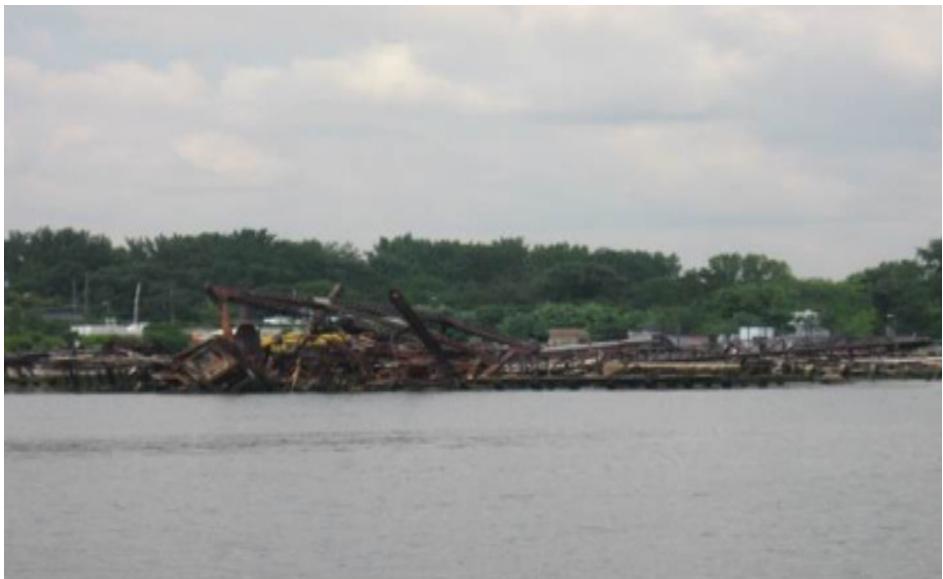
**Mariners Harbor, Bulkhead and Piers**  
**06.27.2014**

Old wreckage at the waterfront  
of Arlington near the Mariners  
Harbor Yacht Club.

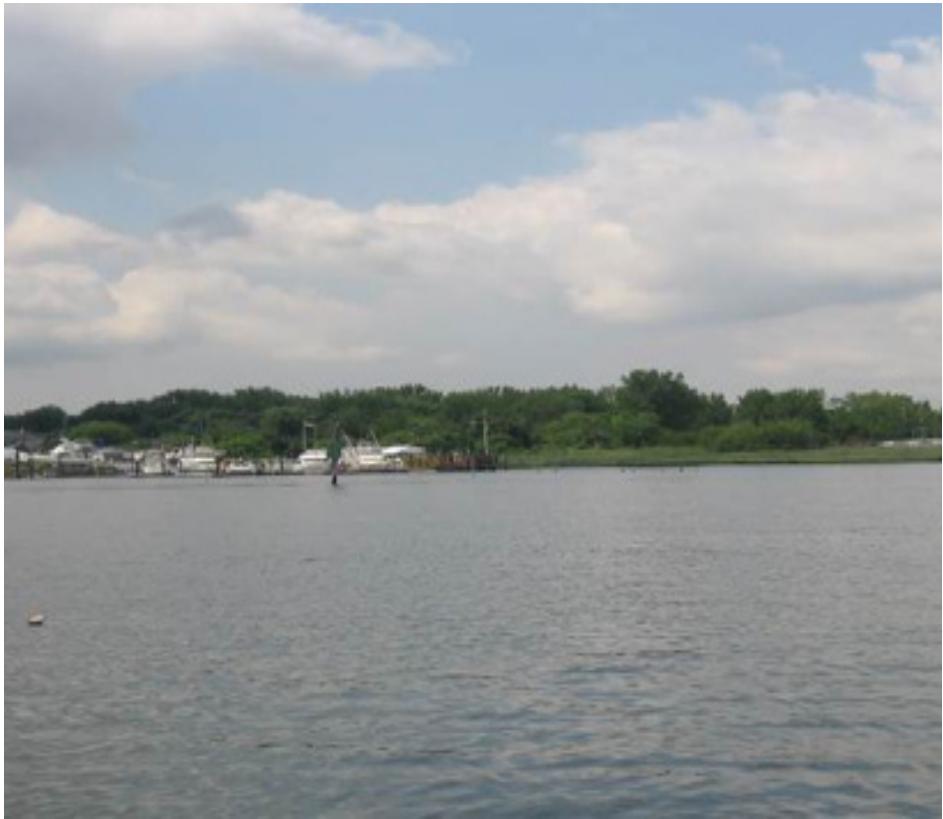
**Old Port Ivory**

Old Port Ivory property slightly west of the Mariners Harbor Yacht Club. The yacht club has piers, but the old Port Ivory property has gone back to being tidal wetlands.

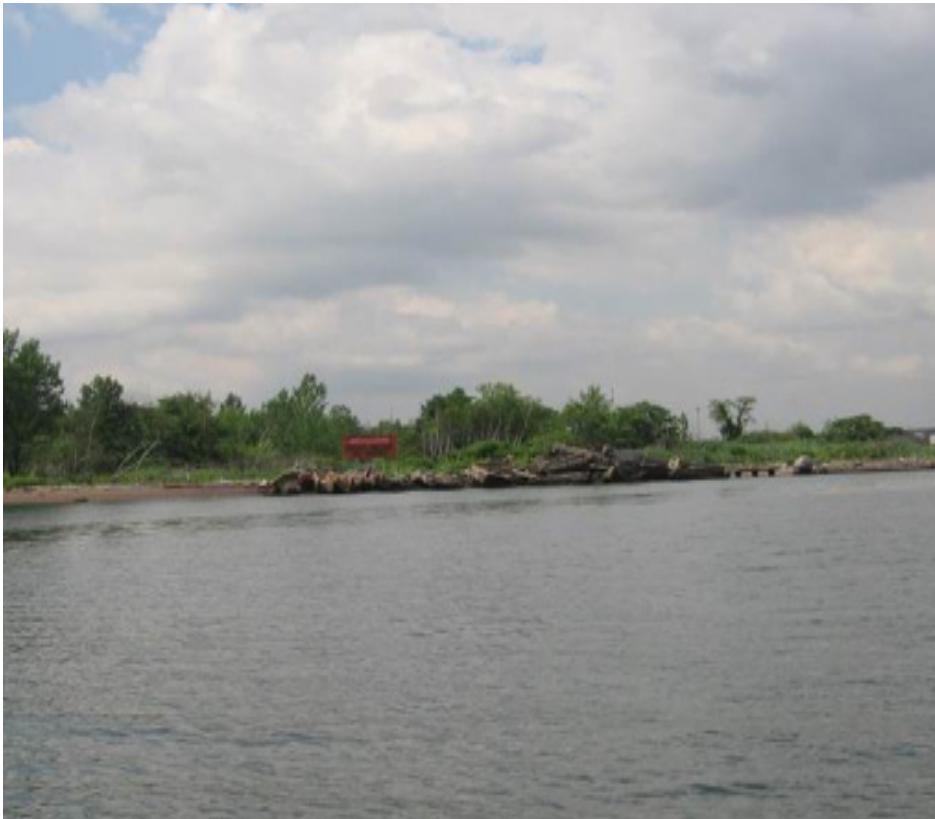
**Arlington Marsh 80 Acres Tidal Wetlands and Cove  
A Natural Resiliency Buffer**

Making the bend to Arlington Marsh, this stretch of Arlington Marsh has a sand beach that is often times covered with debris and garbage that has floated on it. The tidal wetlands and cove of Arlington Marsh and the freshwater wetlands of Mariners Marsh acted as natural buffers and sponges when Hurricane Sandy's storm surge hit the island. The residents living near these wetlands were protected from the storm surge and flooding.

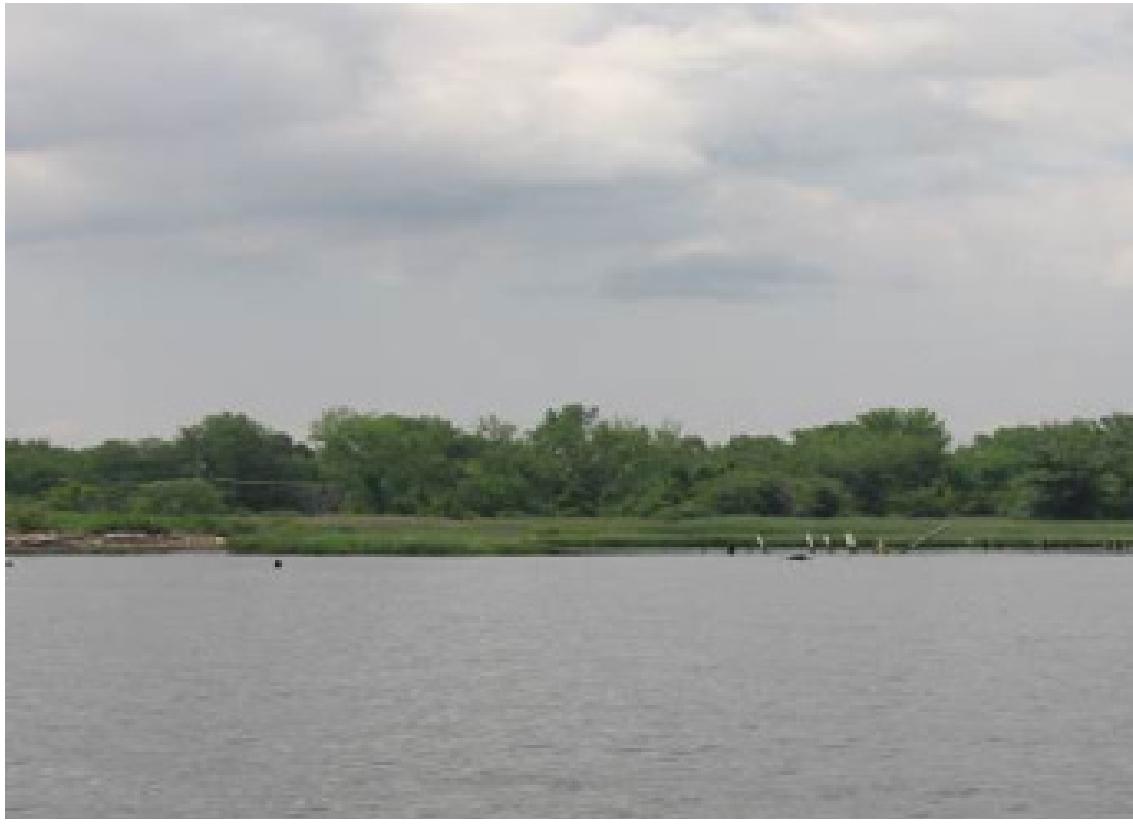
### **Arlington Marsh and its Cove Tidal Wetlands**

The existing bulkheads were never designed as protective buffers from Nor'Easters, hurricane, or climate change impacts such as sea level rising and storms that bring high-wind storm surges that can easily top the bulkheads.

In addition, hard shoreline areas next to unprotected areas may also be increasing the rapid erosion of the unprotected areas of the waterfront. This shoreline erosion is very problematic especially for properties that may have contamination issues that they have tried to cap in some way. A more permanent solution is needed.
